## Voda Cleaning & Restoration of Jersey City

Summary of Loss Report

26-00021-WAT

Water Damage

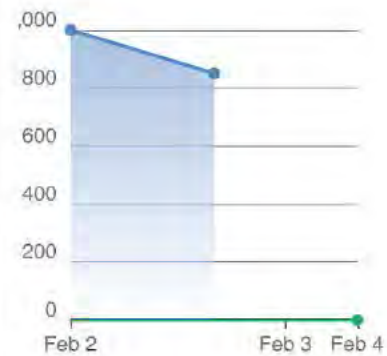
Wall Point - 2

Material  
Drywall

| | 02/02 | 02/03 | 02/04 |
|---|---|---|---|
| Affected | 999.0% | 850.0% | - |

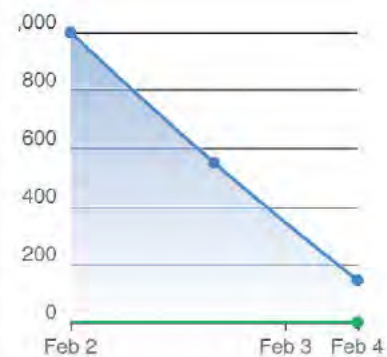
Wall Point - 1

Material  
Drywall

| | 02/02 | 02/03 | 02/04 |
|---|---|---|---|
| Affected | 999.0% | 550.0% | 145.0% |

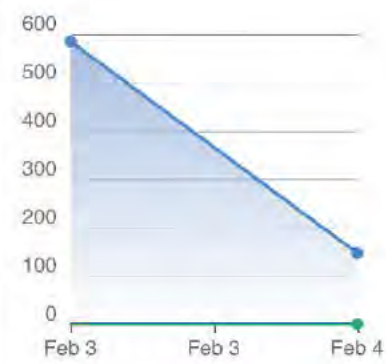
Wall Point - 2

Material  
Drywall

| | 02/03 | 02/04 |
|---|---|---|
| Affected | 584.0% | 146.0% |

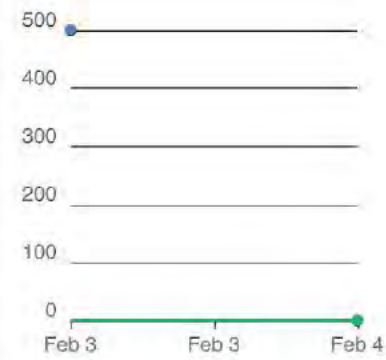
Wall Point - 3

Material  
Drywall

| | 02/03 | 02/04 |
|---|---|---|
| Affected | 500.0% | - |

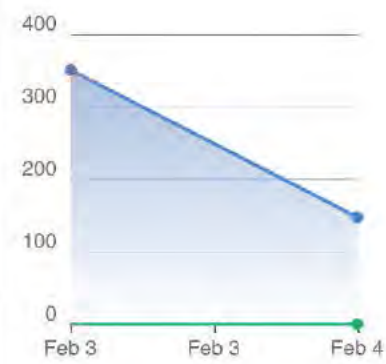
Wall Point - 4

Material  
Drywall

| | 02/03 | 02/04 |
|---|---|---|
| Affected | 350.0% | 147.0% |

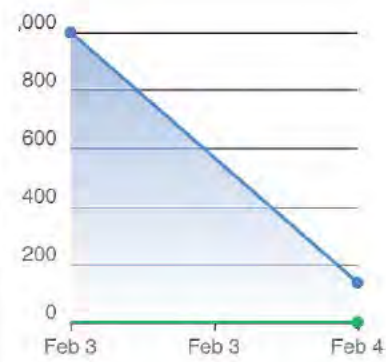
Wall Point - 1

Material  
Drywall

| | 02/03 | 02/04 |
|---|---|---|
| Affected | 999.0% | 137.0% |

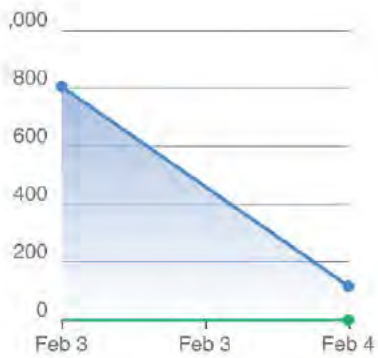
Wall Point - 5

Material  
Drywall

| | 02/03 | 02/04 |
|---|---|---|
| Affected | 804.0% | 116.0% |

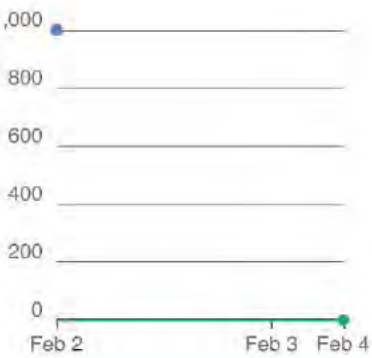
Wall Point - 1

Material  
Particle Board

| | 02/02 | 02/04 |
|---|---|---|
| Affected | 999.0% | - |

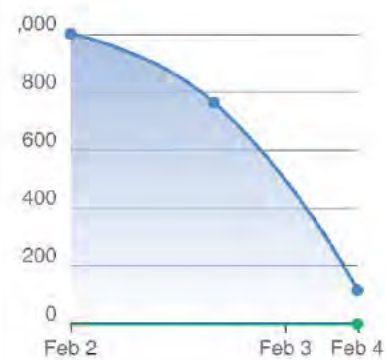
Wall Point - 1

Material  
Drywall

| | 02/02 | 02/03 | 02/04 |
|---|---|---|---|
| Affected | 999.0% | 763.0% | 116.0% |

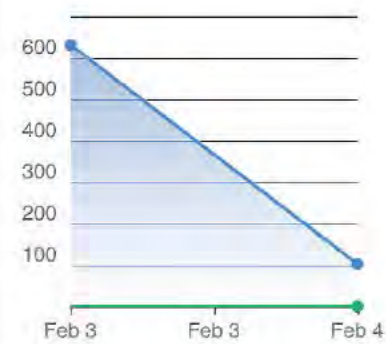
Wall Point - 2

Material  
Drywall

| | 02/03 | 02/04 |
|---|---|---|
| Affected | 630.0% | 102.0% |

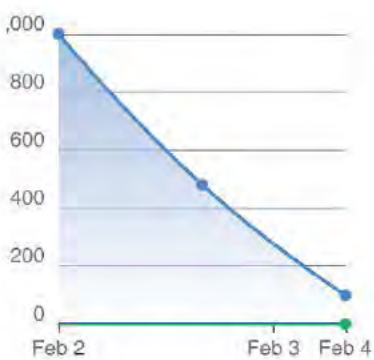
Wall Point - 1

Material  
Drywall

| | 02/02 | 02/03 | 02/04 |
|---|---|---|---|
| Affected | 999.0% | 480.0% | 99.0% |

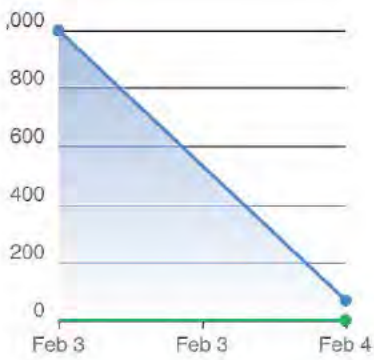
Wall Point - 2

Material  
Drywall

| | 02/03 | 02/04 |
|---|---|---|
| Affected | 999.0% | 69.0% |

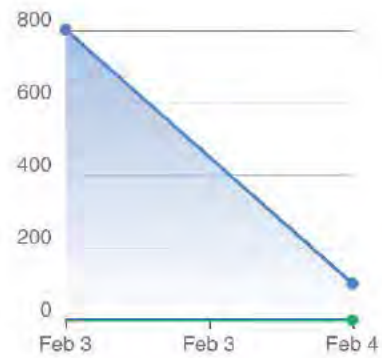
Wall Point - 3

Material  
Drywall

| | 02/03 | 02/04 |
|---|---|---|
| Affected | 800.0% | 100.0% |

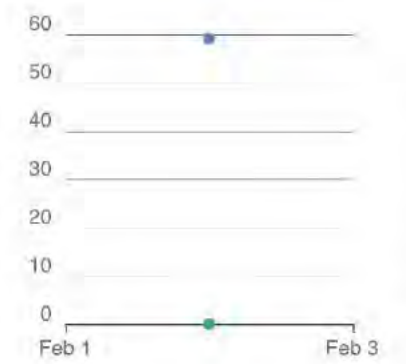
Wall Point - 1

| Affected | 59.0% |

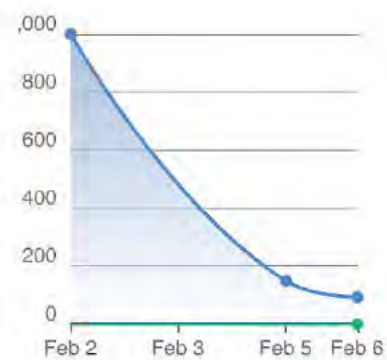
Floor Point - 1

Material  
GlueDown

| | 02/02 | 02/05 | 02/06 |
|---|---|---|---|
| Affected | 999.0% | 149.0% | 92.0% |

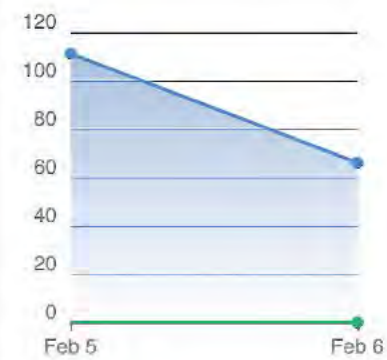
Wall Point - 2

Material  
Drywall

| | 02/05 | 02/06 |
|---|---|---|
| Affected | 111.0% | 66.0% |

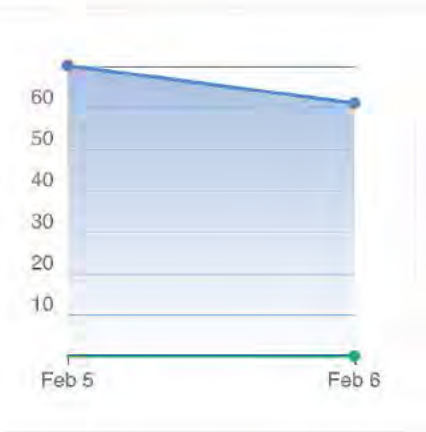
Wall Point - 3

Material  
Drywall

| | 02/05 | 02/06 |
|---|---|---|
| Affected | 70.0% | 61.0% |

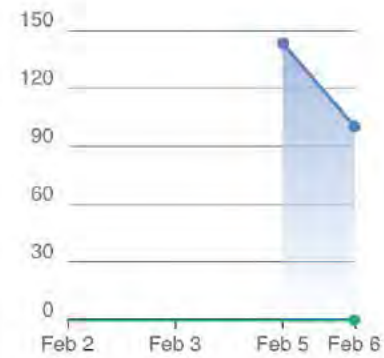
Floor Point - 1

Material  
GlueDown

| | 02/02 | 02/05 | 02/06 |
|---|---|---|---|
| Affected | - | 143.0% | 100.0% |

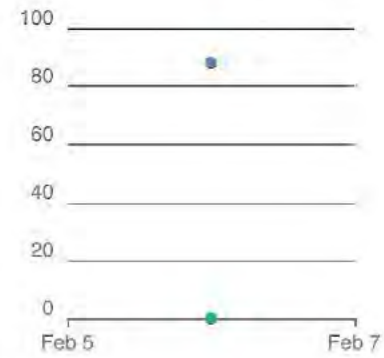
Ceiling Point - 3

Material  
Drywall

| | 02/06 |
|---|---|
| Affected | 88.0% |

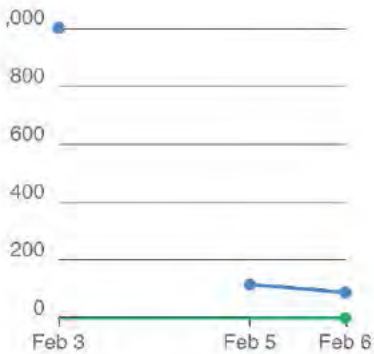
Wall Point - 4

Material  
Wood Sill Plate

| | 02/03 | 02/04 | 02/05 | 02/06 |
|---|---|---|---|---|
| Affected | 999.0% | - | 115.0% | 88.0% |

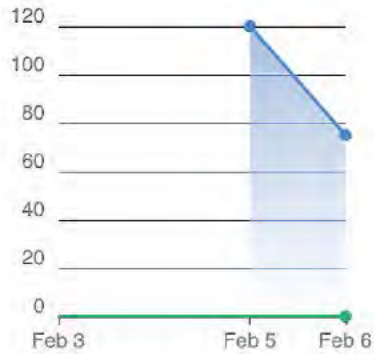
Material  
Wood Sill Plate

✔ Marked dry on 02/05/2026 03:53 PM

| | 02/03 | 02/04 | 02/05 | 02/06 |
|---|---|---|---|---|
| Affected | - | - | 120.0% | 75.0% |
