## Voda Cleaning & Restoration of Jersey City

Summary of Loss Report

26-00021-WAT

Water Damage

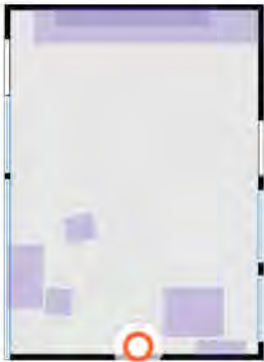
Wall Point - 2

| 02/04 | |
|---|---|
| Affected | — |

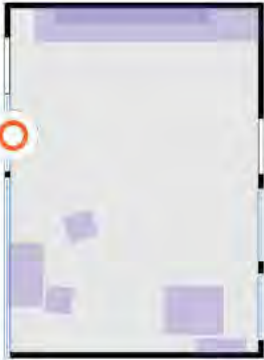
Wall Point - 3

| 02/04 | |
|---|---|
| Affected | 60.0% |

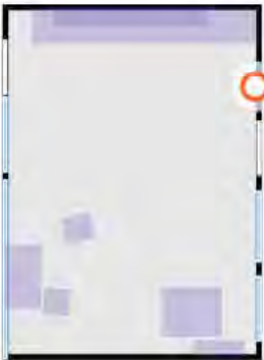
Wall Point - 4

| 02/04 | |
|---|---|
| Affected | 267.0% |

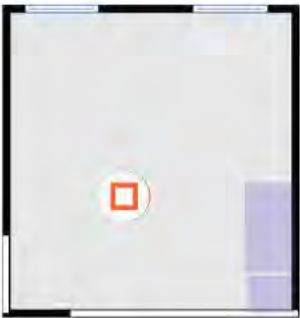
Floor Point - 1

Material  
GlueDown

| | 02/02 | 02/05 | 02/06 |
|---|---|---|---|
| Affected | - | 143.0% | 100.0% |

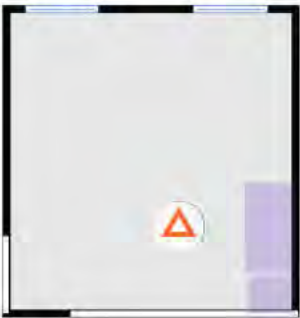
Ceiling Point - 3

Material  
Drywall

| | 02/06 |
|---|---|
| Affected | 88.0% |

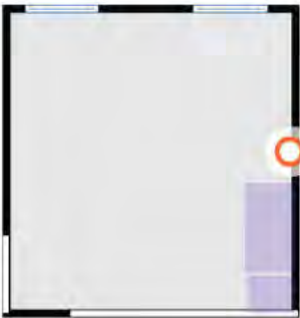
Wall Point - 4

Material  
Wood Sill Plate

| | 02/03 | 02/04 | 02/05 | 02/06 |
|---|---|---|---|---|
| Affected | 999.0% | - | 115.0% | 88.0% |

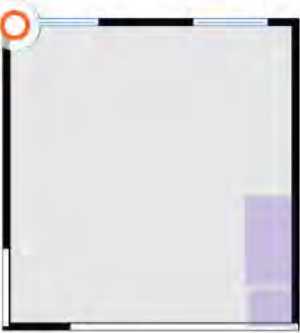
Material  
Wood Sill Plate

✔ Marked dry on 02/05/2026 03:53 PM

| | 02/03 | 02/04 | 02/05 | 02/06 |
|---|---|---|---|---|
| Affected | - | - | 120.0% | 75.0% |
